# Luton Airport

June 2017

## Site Monitoring Report

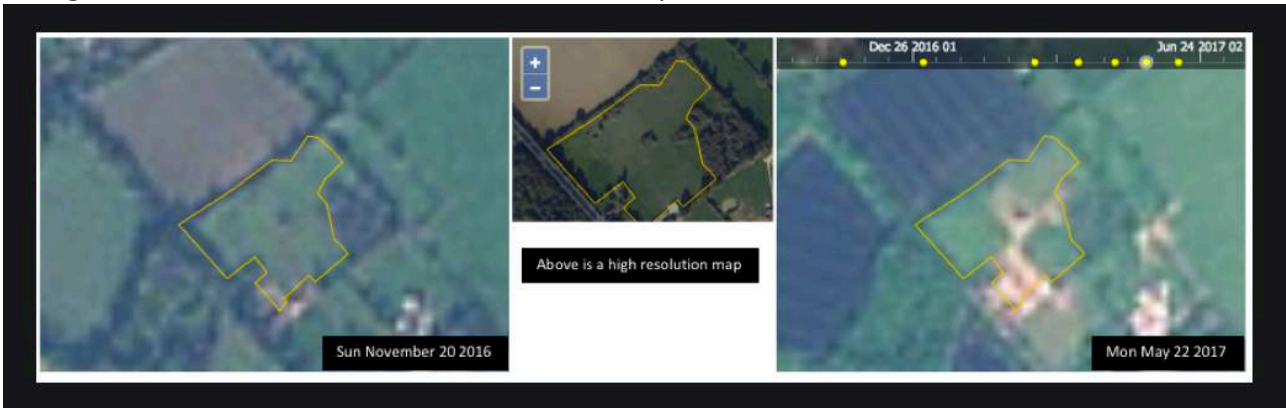
### Site change 1

Below a change in a pasture has been identified. In the satellite data you can see that there is a change to the site from November 20, 2016 to May 22, 2017.

**Conclusion:** The site development is to be continuously monitored. The inspection cycle is 6 months. If the changes continue the need for an onsite inspection will be evaluated.

**Action:** Continually monitoring

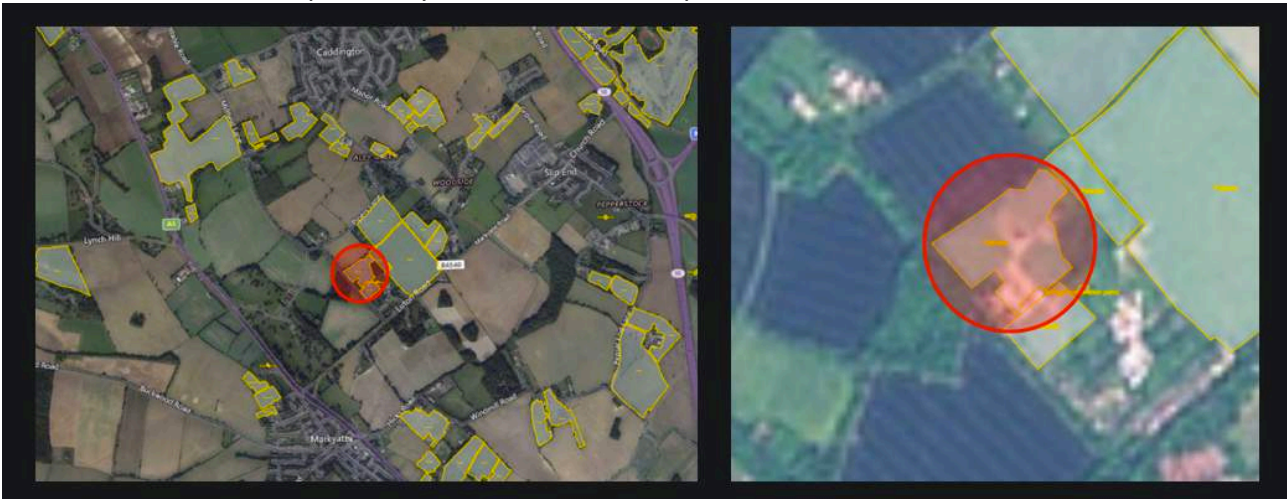
**Site location:** In the map below you can see the site position.

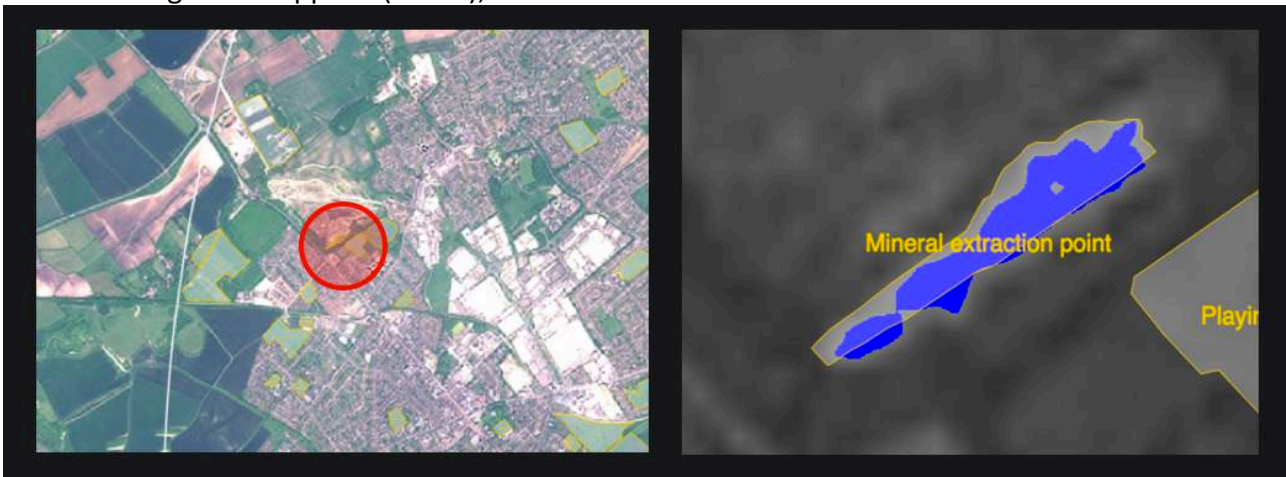
**Site location:** In the map below you can see the site position to the left. On the right you see the find water algorithm applied (NDWI), this also indicates a reduction in the water surface.

**Action:** Continually monitoring

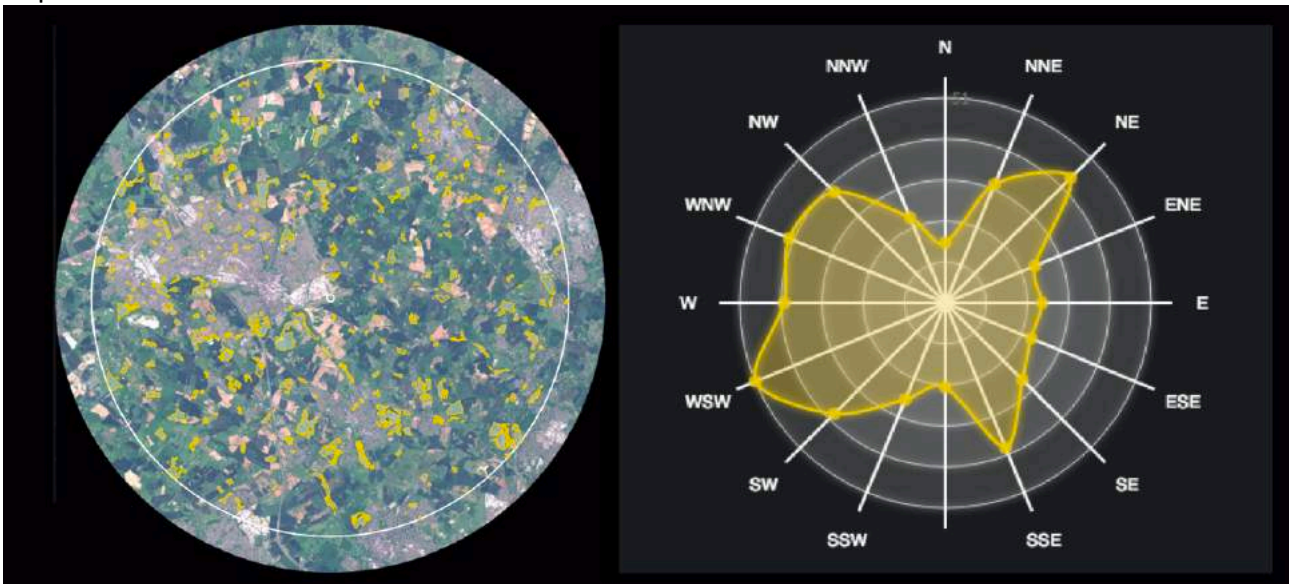
The 13 km safeguarding zone and all sites registered in the zone is visualized to the left in the image below. To the right, registered sites in relation to 16 compass directions is shown, centre is the APR. This gives an easy overview of the distributions of sites depending on direction from the airport.

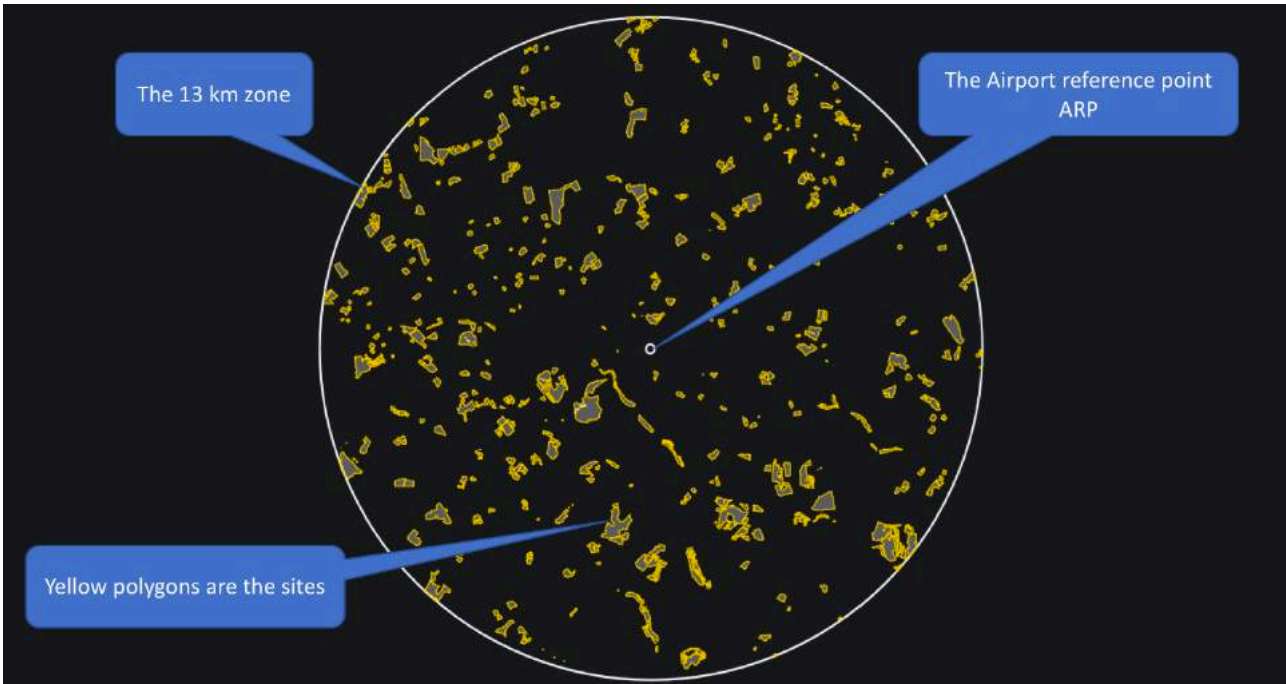
In this section the focus has been on sites that attract specific species. In the image below you can see the “13 km zone”, the ARP and the sites.

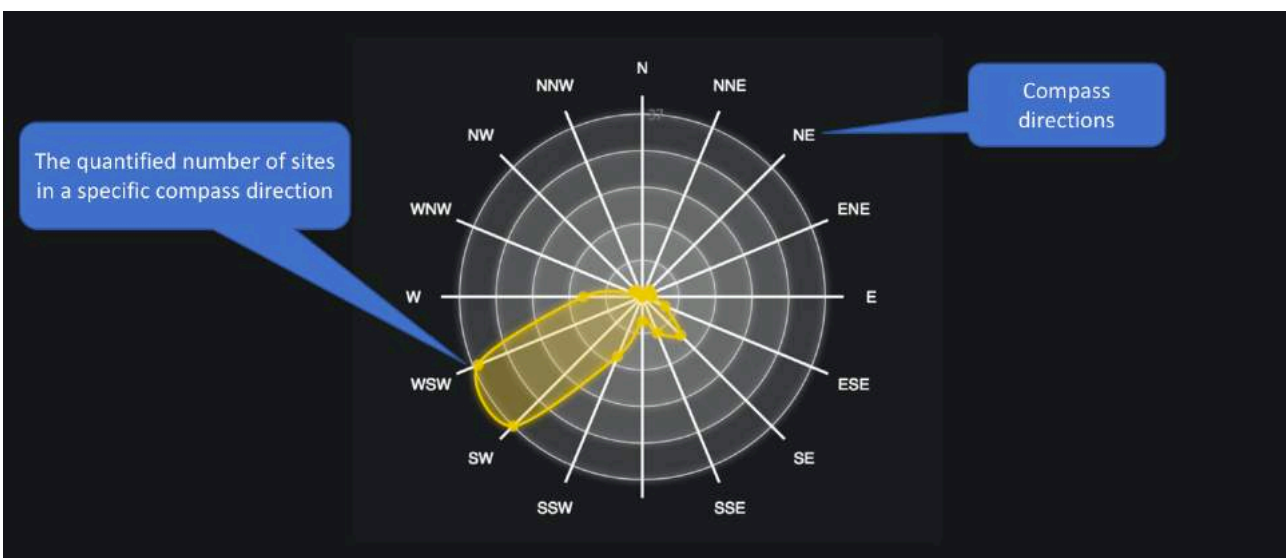
The site distribution depending on direction from the ARP is shown in the figure below with the 16 compass directions.

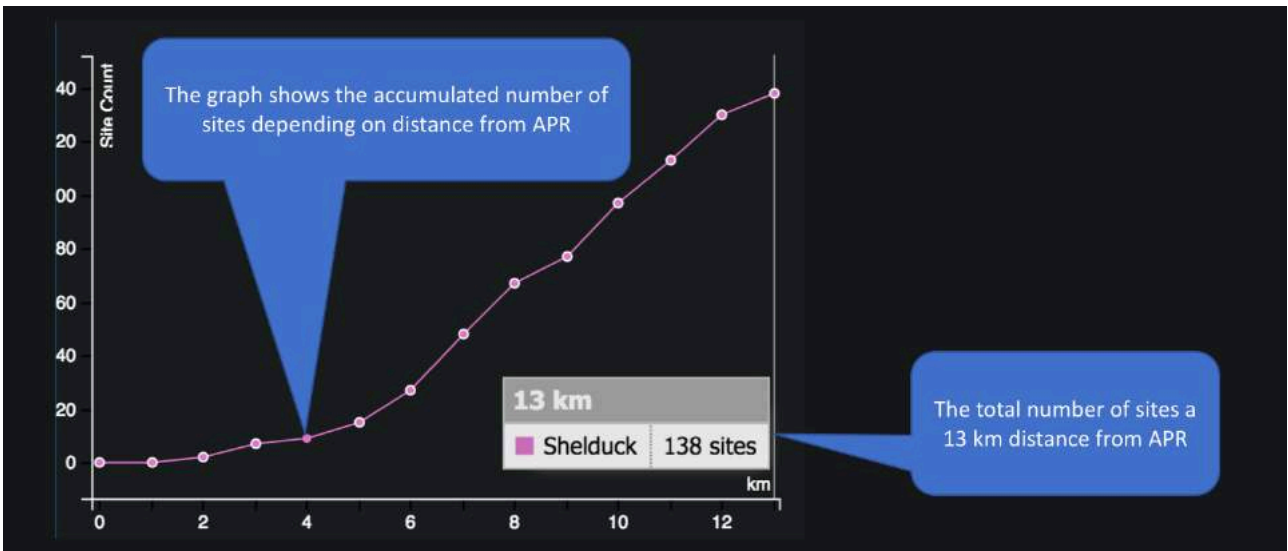
The Graph visualizes the number of sites depending on distance from the ARP as well as the total number of sites in the 13 km zone.
